## Automatic Actuator & Anti-Siphon Valve Repair

# Actuator Repair Kits

# Anti-Siphon Valve Repair Kits

# Troubleshooting Guide

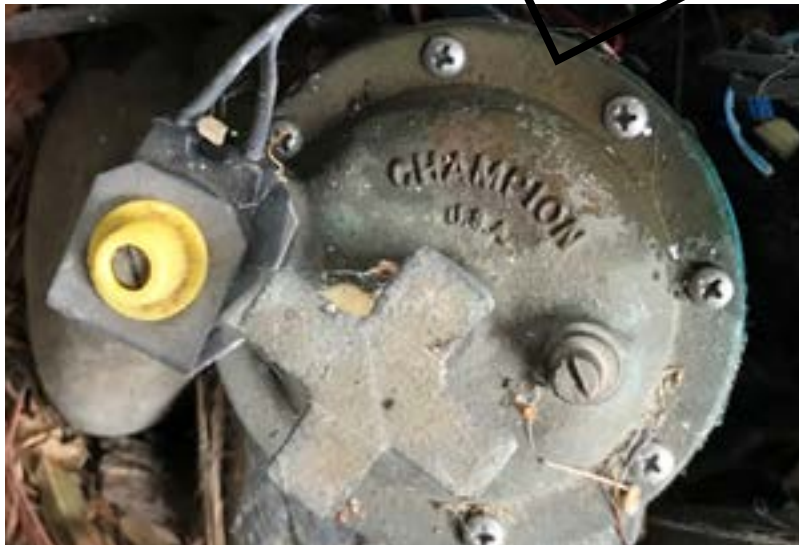
### ***Date code between two screws before 2016***

- Start by double checking that you have a Champion brand actuator. All Champion actuators will have “CHAMPION” stamped on the top of the actuator, as in the image below. If the actuator has a different brand stamped on it, please refer to that manufacturer's repair information.
- Next, identify the manufacturing date of the actuator. If the original documentation is unavailable, you can locate the original manufacturing date on the actuator.
- The date stamp is located between two of the screws around the top or along the side of the hexagon neck above the threads (see images below).
- The date stamp should read as follows:

#### **For Classic (CL) Actuators:**

- Dates before 2004, see page 3
- Dates 2004-2015, see page 4

#### **For Compact (AA/AB) Actuators**

- Dates before 2016, See page 6

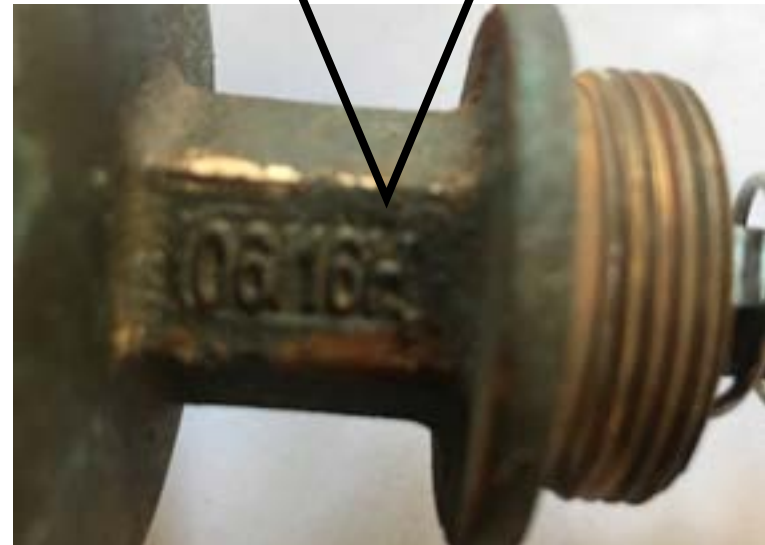
### ***Date code on hexagon neck 2016 and later***

i.e 06/16

#### **For Classic CL Actuators**

- Dates 2016 and later, see page 5

#### **For Compact (AA/AB) Actuators**

- Dates 2016 and later, see page 7

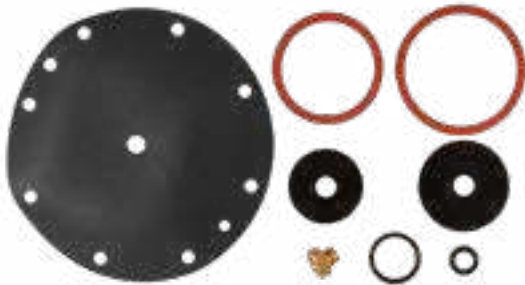
### 1. RK-25C

- For 3/4" & 1" actuators
- Includes replacement diaphragm, seat washer, O-rings, red-fiber gaskets and the short brass metering screw
- Flat 3-3/4" diaphragm with 11 holes total

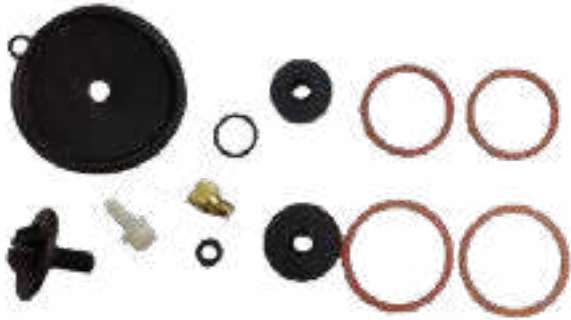
### 1. RK-26C

- For 3/4" & 1" actuators
- Includes replacement diaphragm, seat washer, O-rings, red-fiber gaskets and the short brass metering screw
- Ridged 3.75" diaphragm with outside ring.

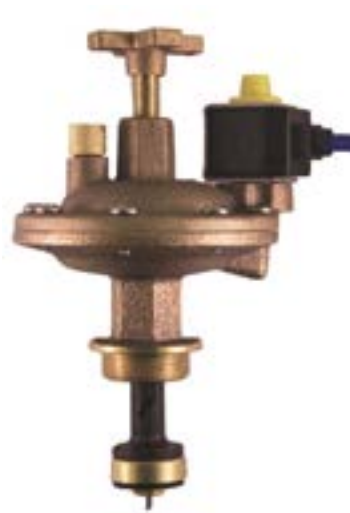
### 3. RK-29C

For actuators manufactured 2004-2015, the diagram shows the available parts sold. Please refer to the "RK" part numbers below for the corresponding repair kits:

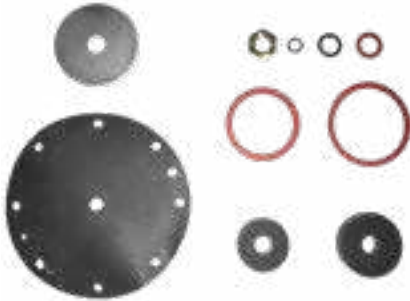
### 1. RK-38C

- For 3/4” & 1” actuators
- Includes replacement diaphragm, seat washer, O-rings, red-fiber gaskets and the short brass metering screw
- Flat 3.75” diaphragm with 11 holes

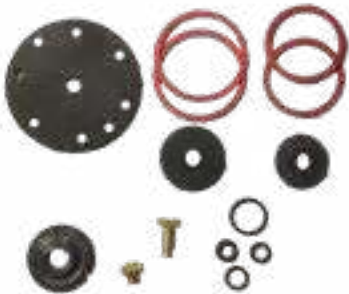
### 1. RK-17C

- Actuator repair kit for 3/4" & 1" compact actuators (made before 2016)
- Includes replacement 2.5" diaphragm, seat washer, O-rings, red-fiber gaskets, diaphragm screw and the metering screw
- Flat diaphragm with 9 holes

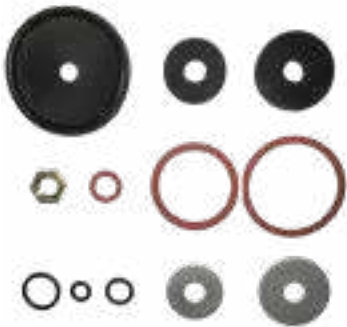
### 1. RK-18C

- For 3/4” & 1” Compact actuators made in 2016 or after.
- Includes replacement 2.5” diaphragm, seat washer, O-rings, fiber gaskets, nuts and steel washers

- Ridged diaphragm
- ### 2. RK-28C

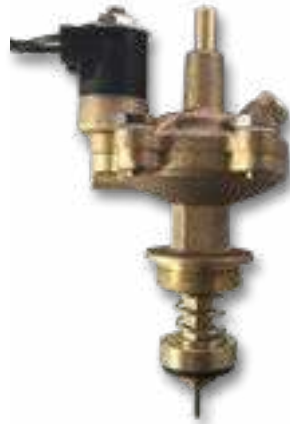
- Replacement Solenoid
- ### 3. RK-29C
- Replacement brass bleed screw with o-ring (2)

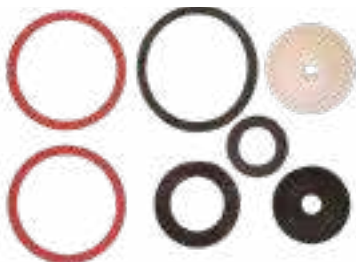
### 3. RK-30C (3/4" valves) or RK-31C (1" valves)

- Full rebuild kit, including Union Gasket
- RK-30C contains parts in RK-1C & RK-4C
- RK-31C contains parts in Rk-2C & RK-5C
